Battery Energy Storage Project, Land East of Contullich, Aness

Archaeological Desk-Based Assessment

RES UK and Ireland Ltd

20 December 2023

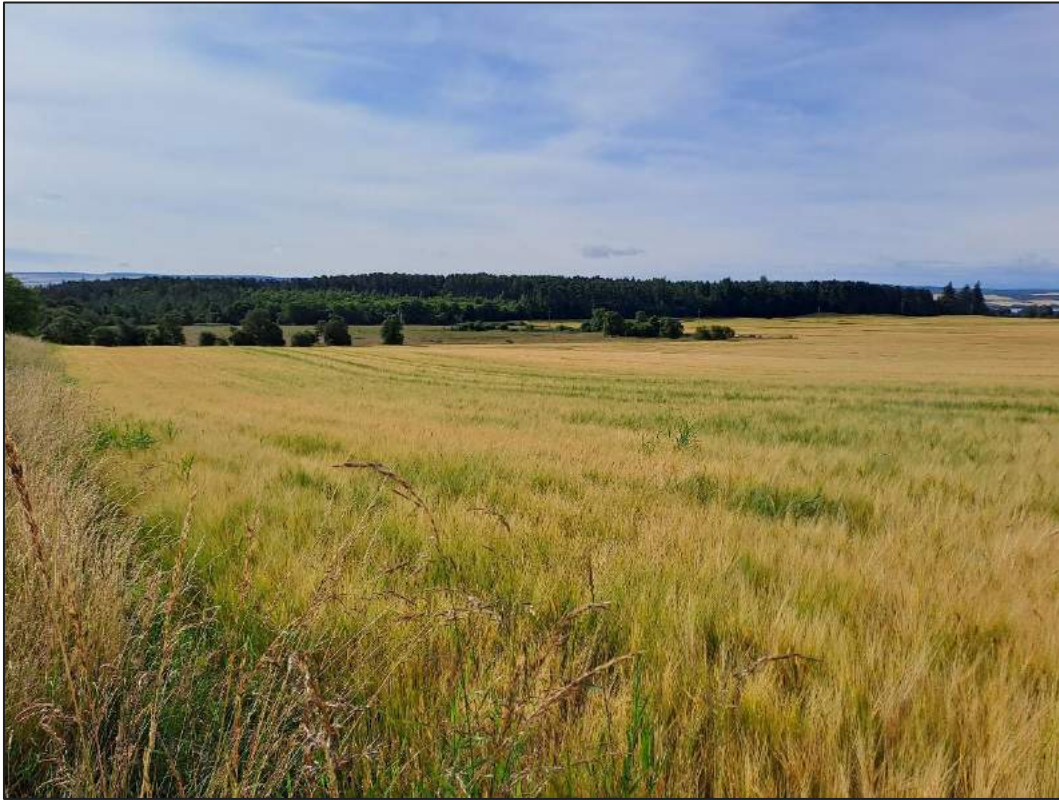
Photograph 1: (NH 64194 71046) View facing southeast from the north of the Site along the north boundary. No cultural heritage assets were identified.

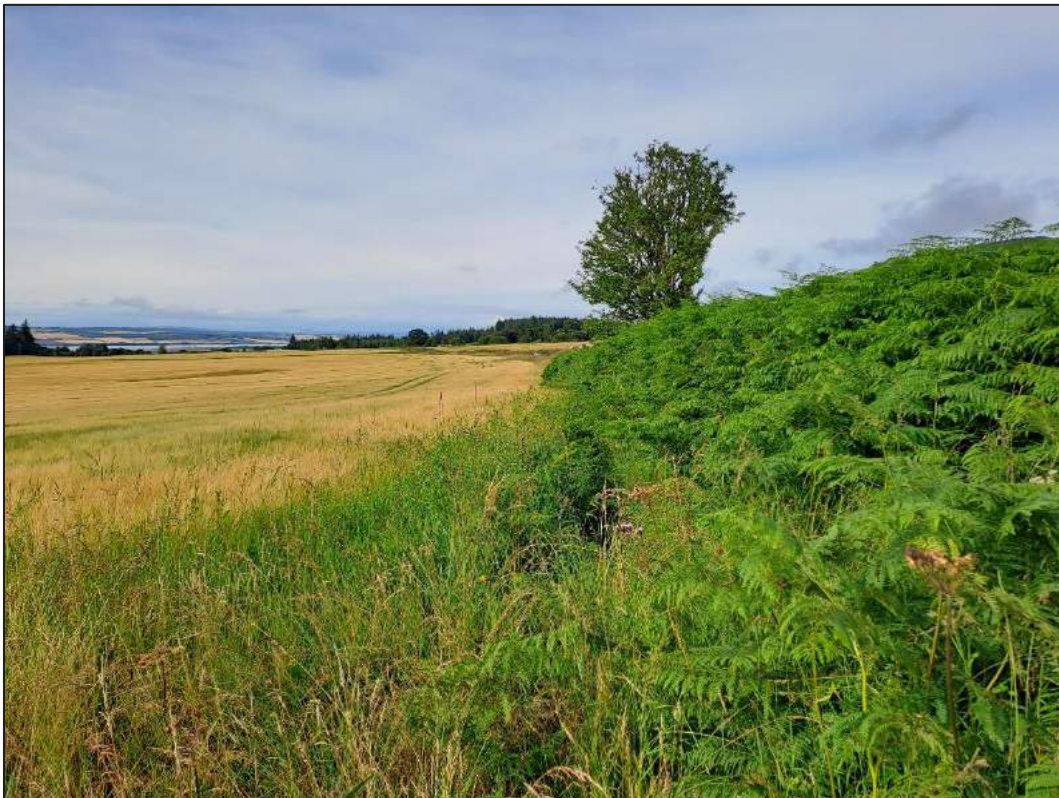
Photograph 2: (NH 64132 71031) View facing south from the north corner of the Site along the west boundary. No cultural heritage assets were identified.

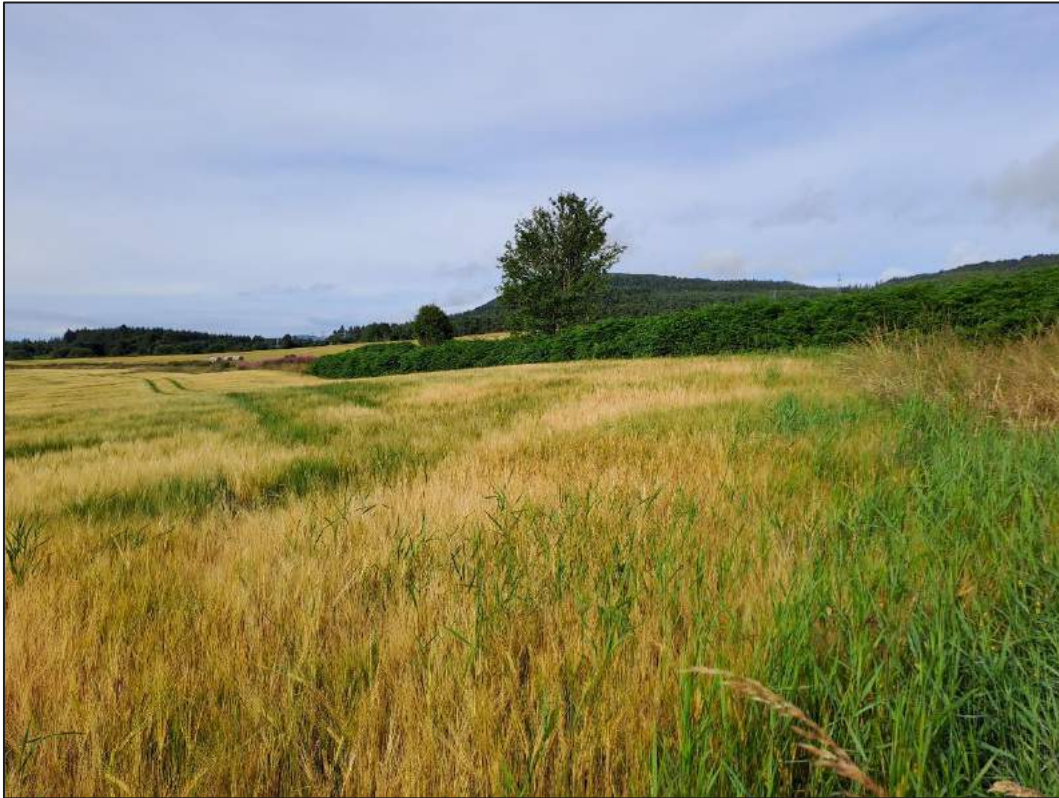
Photograph 3: (NH 64250 71004) View southwest from the northern boundary of the Site. No cultural heritage assets were identified.

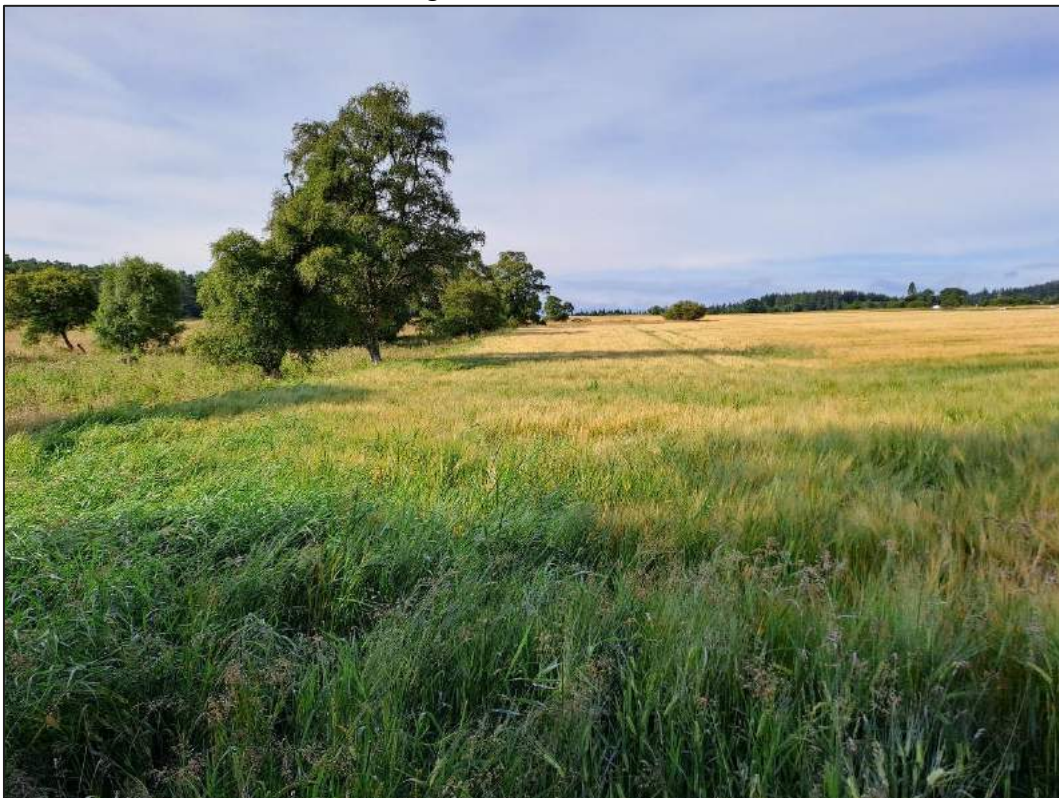
Photograph 4: (NH 64323 70953) View south-southwest along from the northeast corner of the Site, facing along the northeast boundary. No cultural heritage assets were identified.

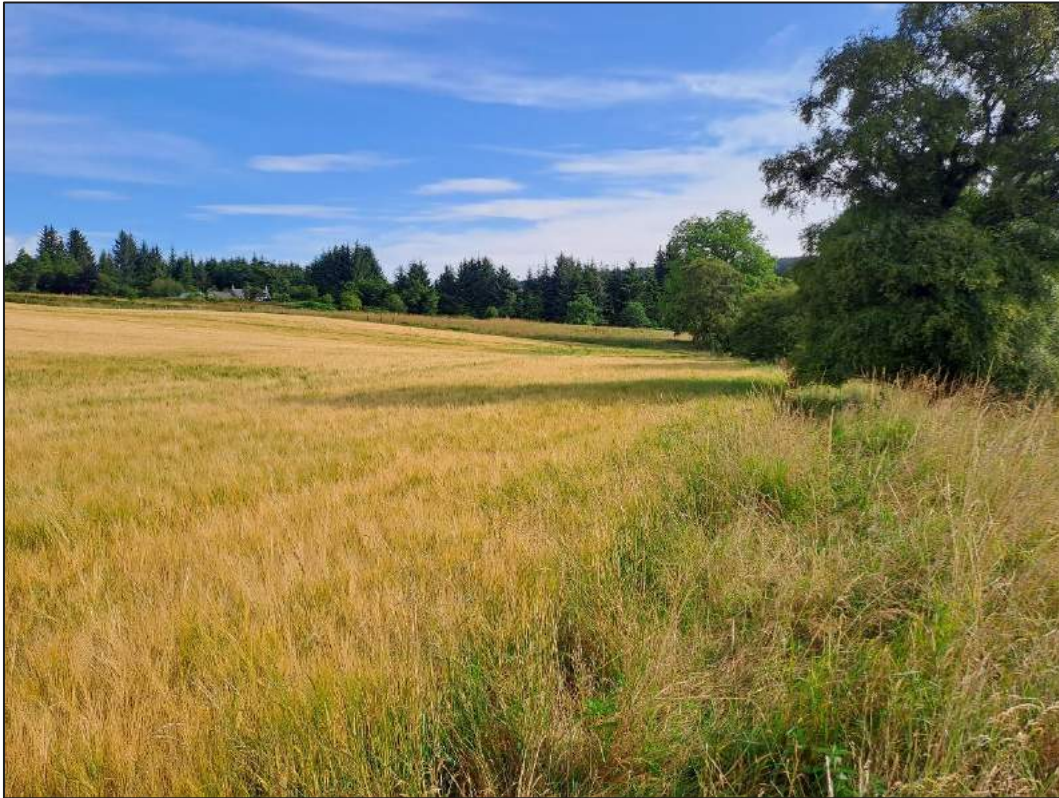
Photograph 5: (NH 64281 70857) View northeast from the northeast of the Site, facing toward the northeast corner. No cultural heritage assets were identified.

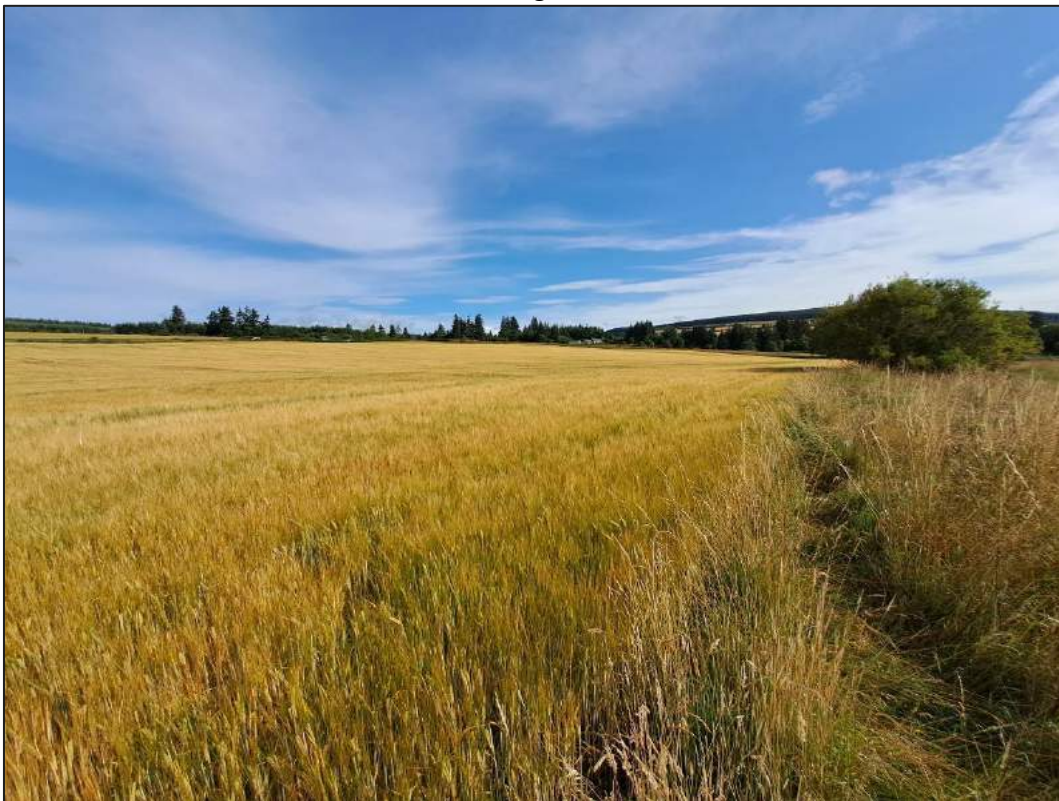
Photograph 6: (NH 64187 70774) View northeast from the inner east corner of the Site boundary, facing along the northeast boundary. No cultural heritage assets were identified.

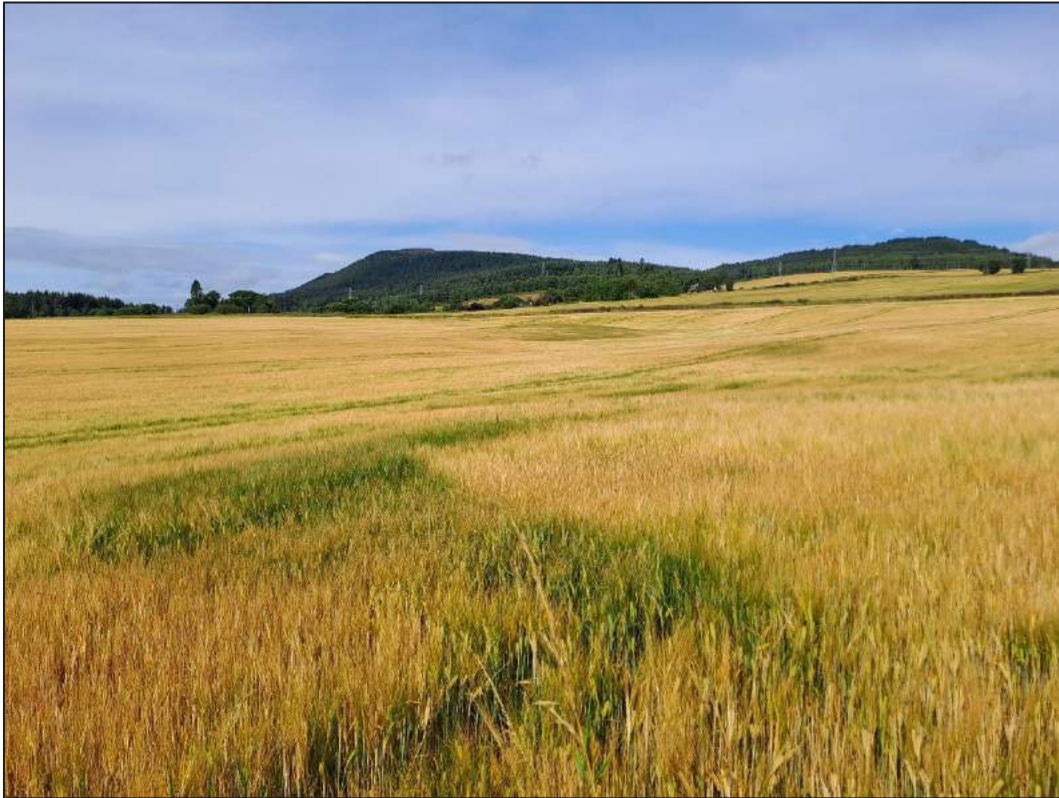
Photograph 7: (NH 64189 70753) View southwest from the inner east corner of the Original Land Under Option boundary toward the centre of the field. Topographic features on the LiDAR are identifiable.

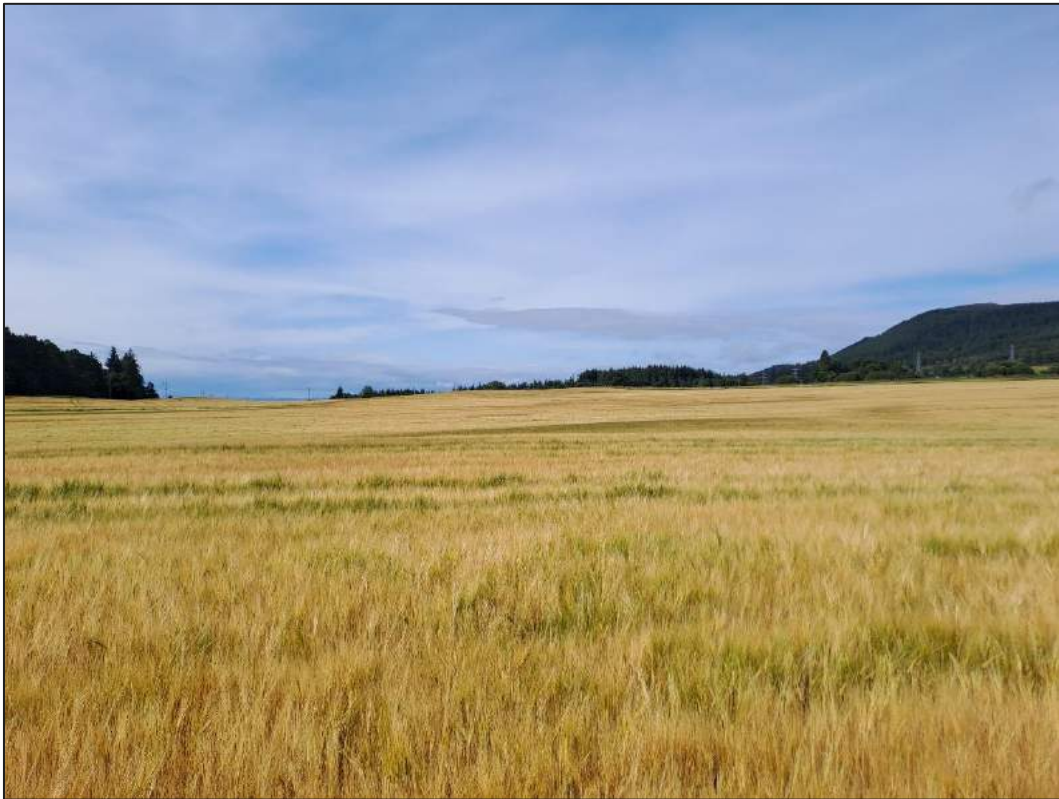
Photograph 8: (NH 64291 70696) View southwest from the east boundary of the Original Land Under Option, toward the cropmark (MHG8317). Faint colouration in the wheat is visible.

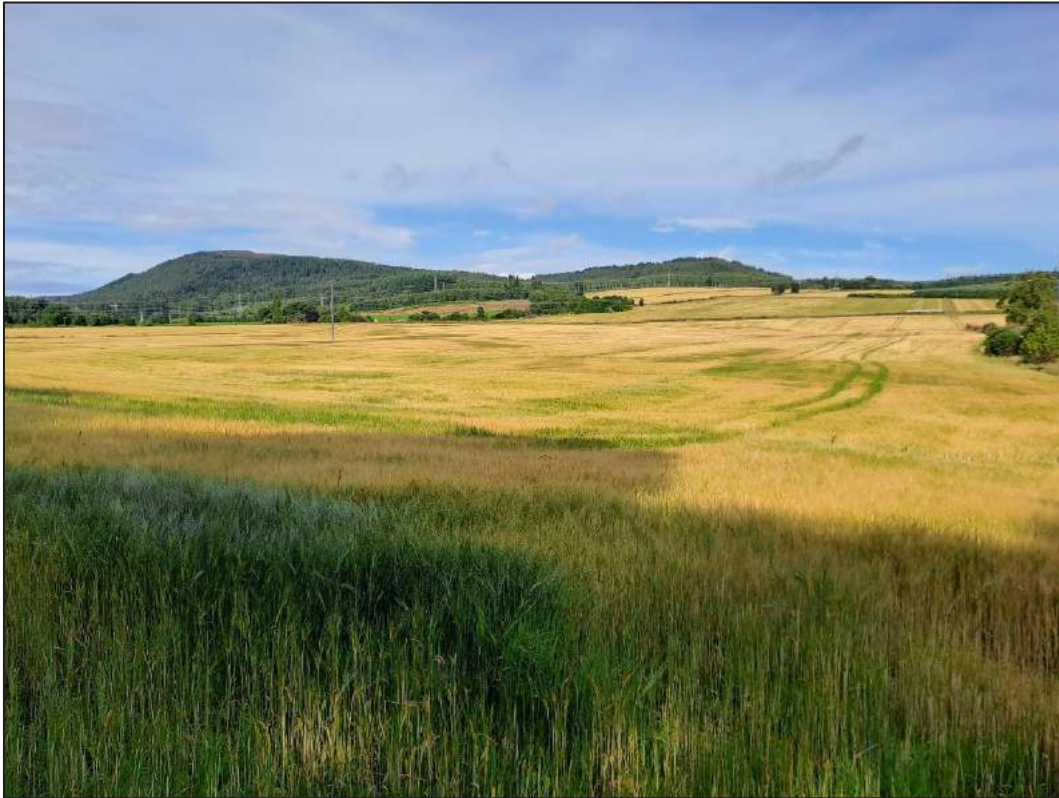
Photograph 9: (NH 64378 70555) View facing southwest from the east outer corner of the Original Land Under Option. There is some discolouration within the crops, but the enclosure cropmark (MHG8317) is not discernible.

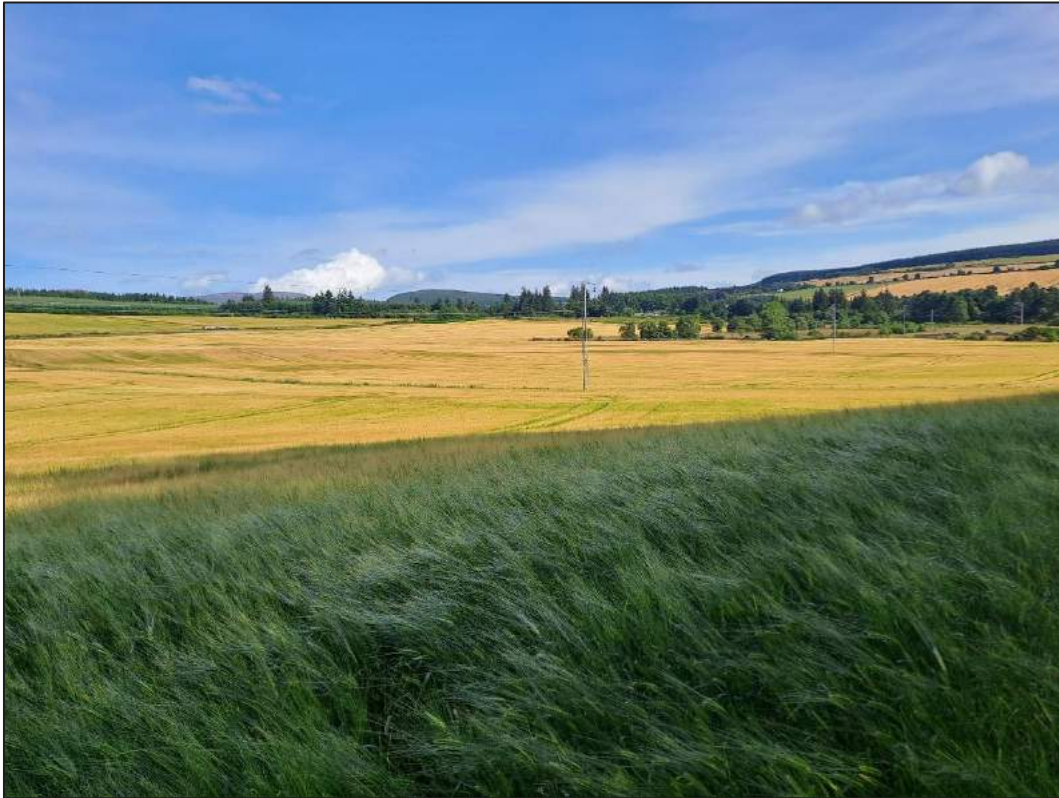
Photograph 11: (NH 64214 70432) View north from the southeast boundary of the Original Land Under Option. No cultural heritage assets were identified.

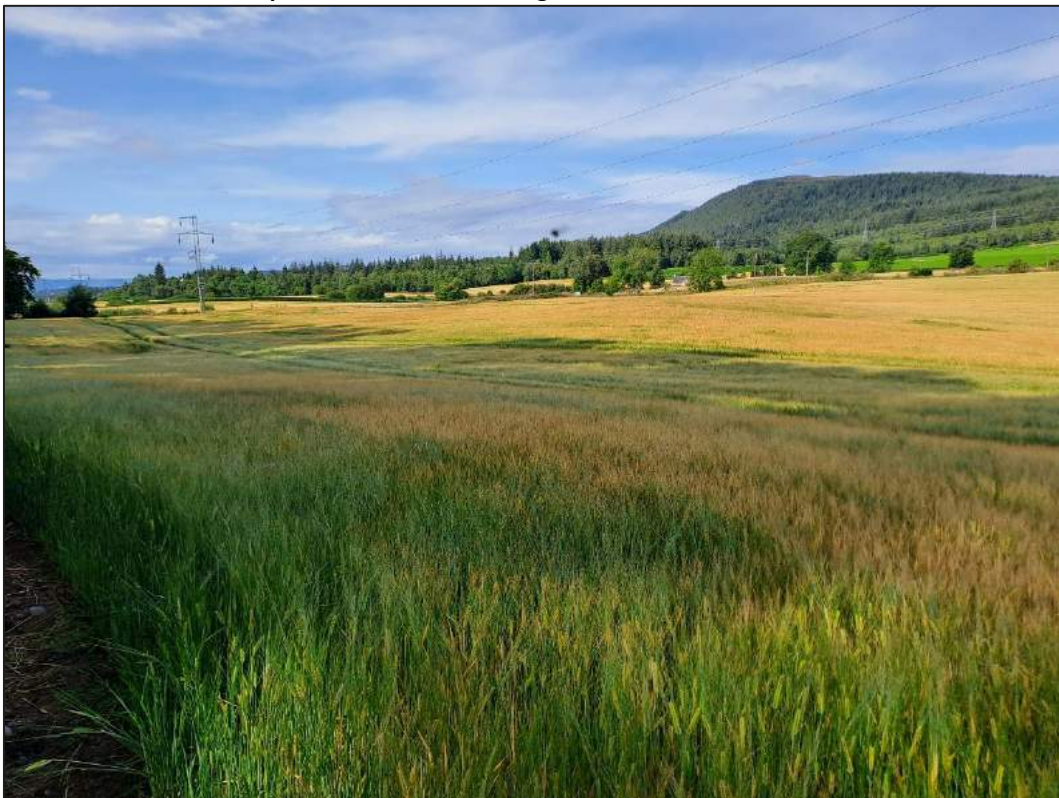
Photograph 12: (NH 64184 70412) View southwest from the southeast boundary of the Original Land Under Option. No cultural heritage assets were identified.

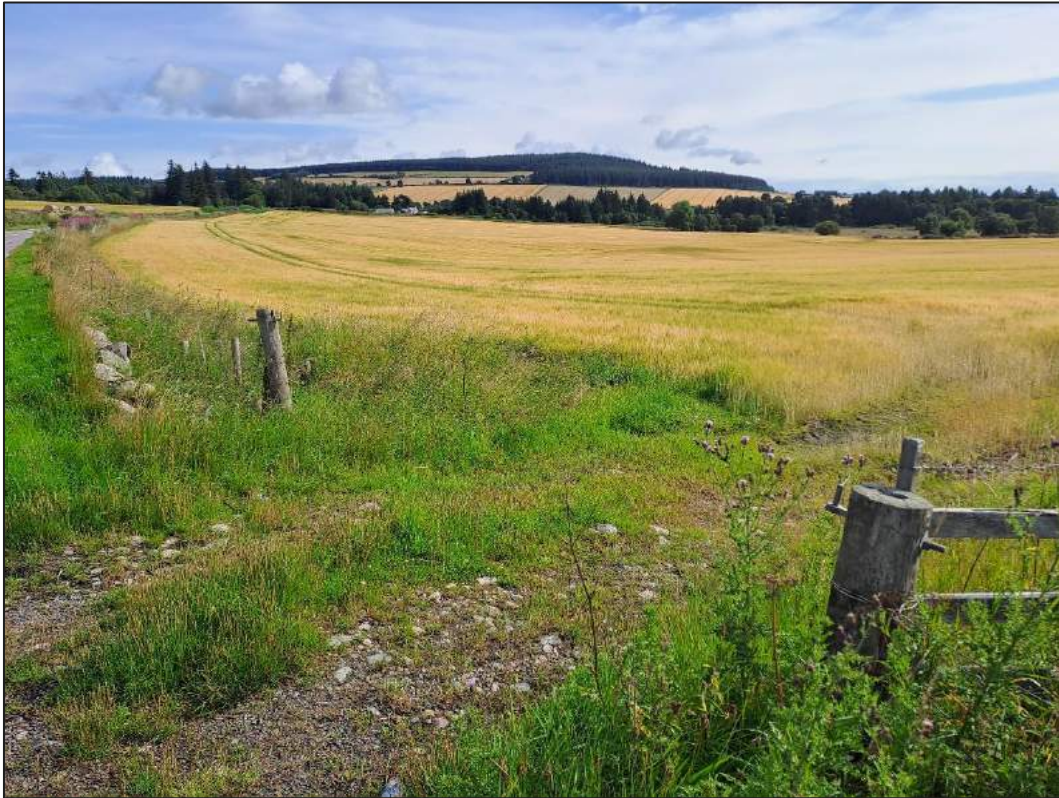
Photograph 13: (NH 64019 70889) View northeast from the entrance to the field along the northwest boundary of the Original Land Under Option from the B9176.

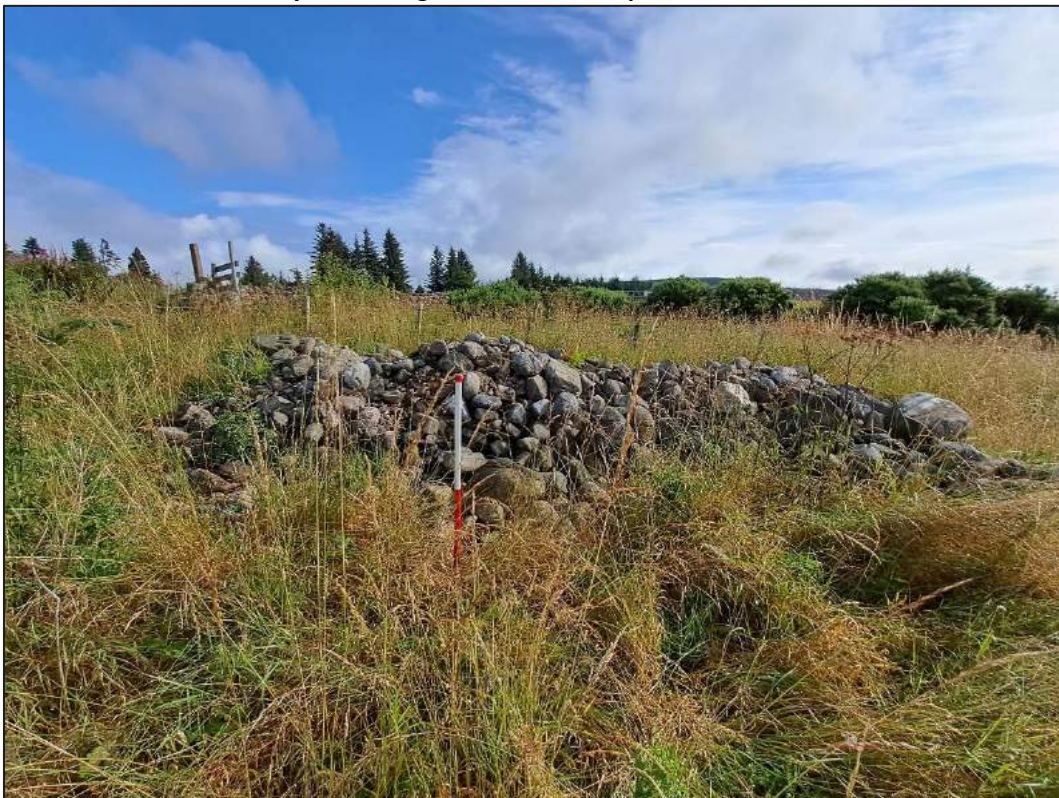
Photograph 14 (Appendix C) shows a modern clearance cairn (SLR 1) in the northwestern corner of the Site. This cairn is fairly large and potentially represents spoil from a disused drystone wall, but otherwise consistent with stone clearing for continued agricultural use. Stone clearing cairns were noted in several corners of the field, most of which were likely very recent given the lack of vegetation/overgrowth on the stones, though one cairn (SLR 3), was considerably more overgrown, with mature trees growing from it, which may suggest a post-medieval or earlier origin.

(SLR 1) Photograph 14: (NH 64147 71049) View facing north within the north-most corner of the Site. Modern clearance cairn.

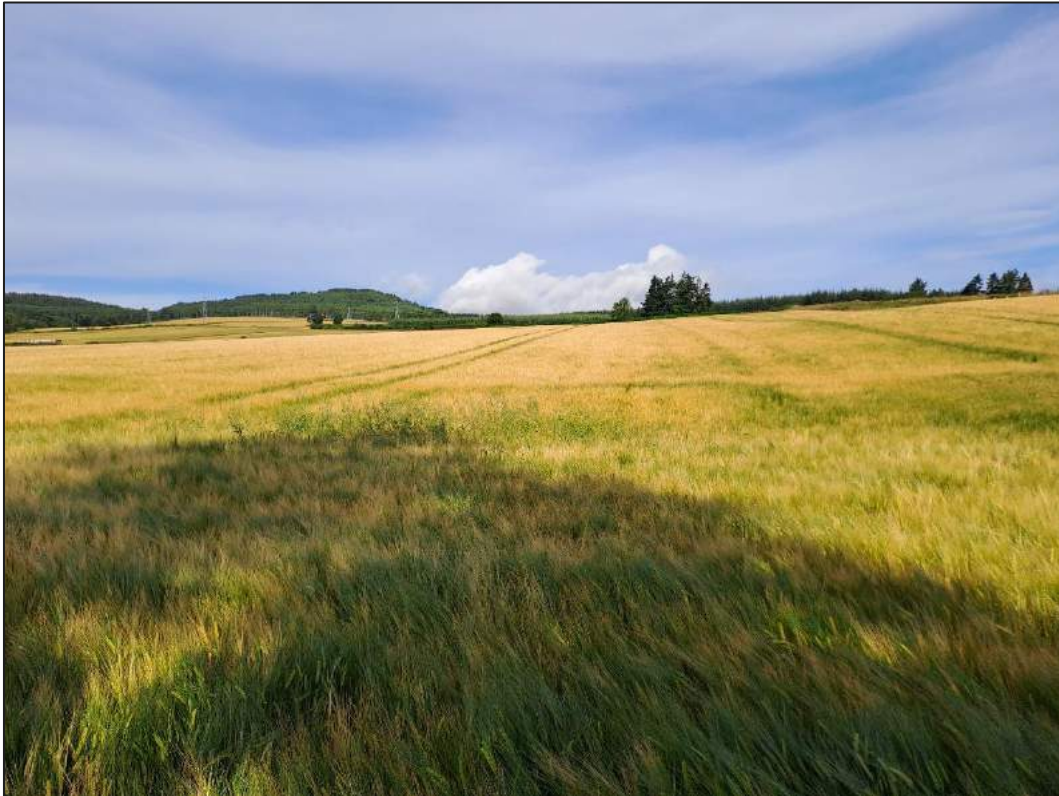
(SLR2) Photograph 15: (NH 64317 70921) View west within the northeast most corner of the Site. A potential curvilinear cropmark, although consistent with track marks.

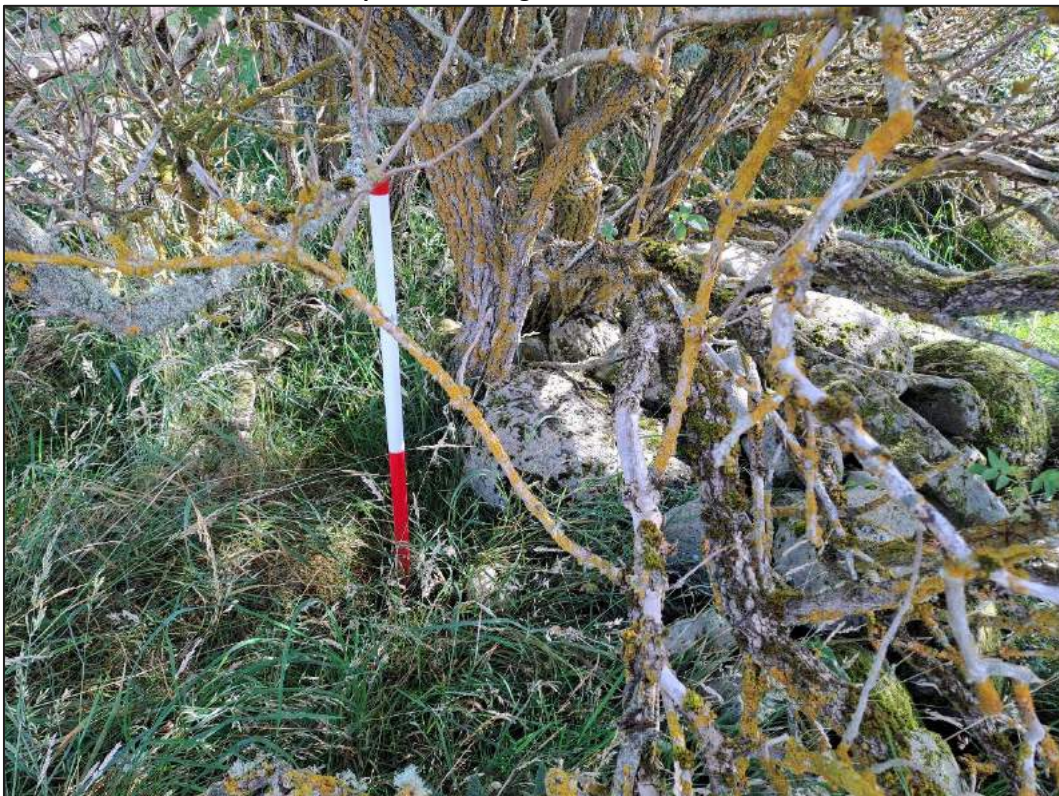
(SLR 3) Photograph 16: (NH 64190 70780) View north at the inner east corner of the Site. A late post-medieval to modern clearance cairn with overgrowth.

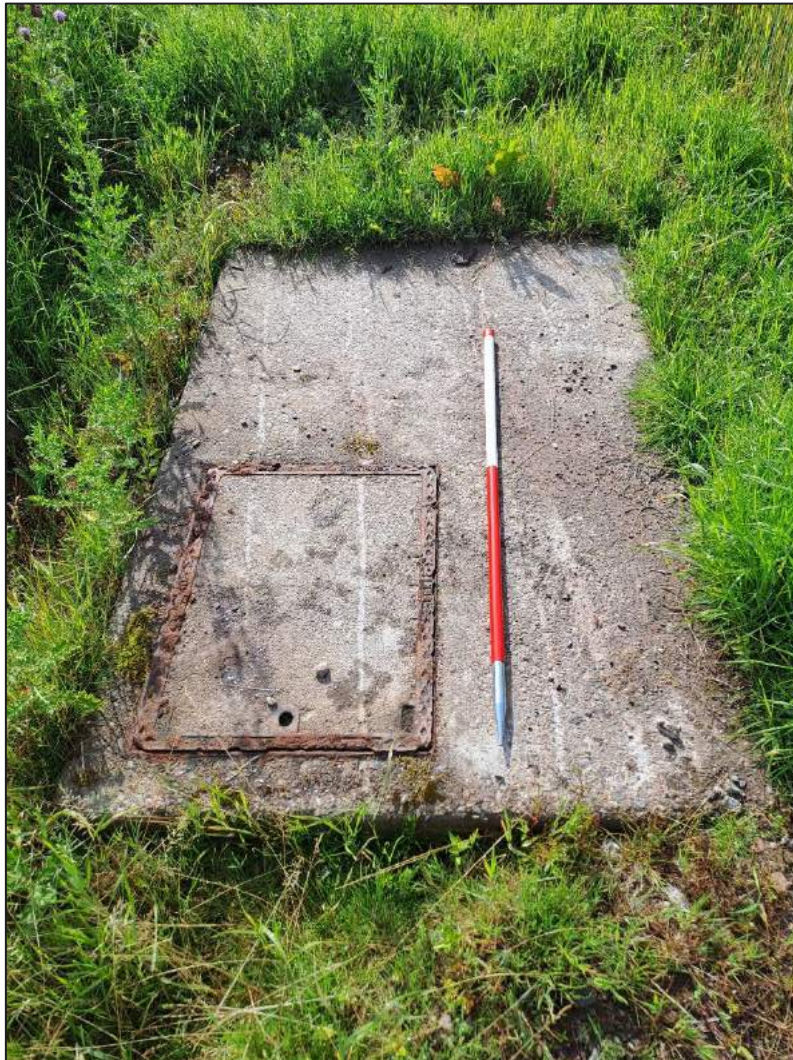
(SLR 4) Photograph 17: (NH 64396 70615) View east within the east outer corner of the Original Land Under Option. A modern concrete slab, likely related to below ground infrastructure.

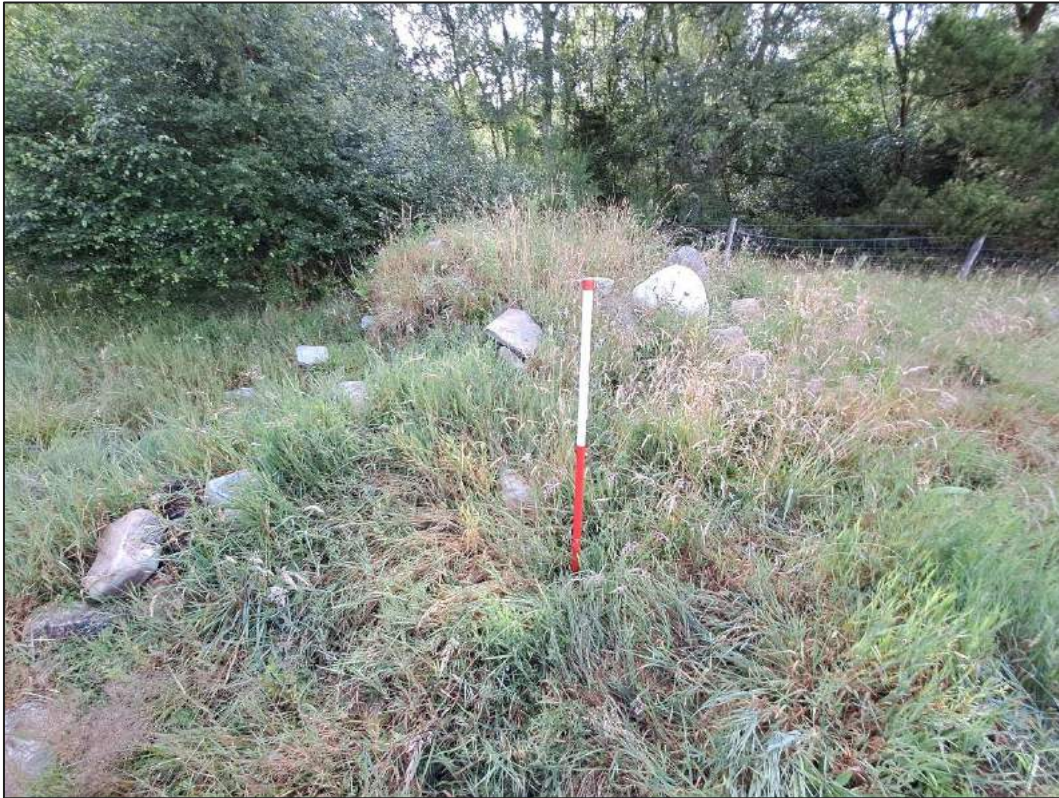
(SLR 5) Photograph 18: (NH 64416 70604) View northeast within the east outer corner of the Original Land Under Option. A modern clearance cairn.

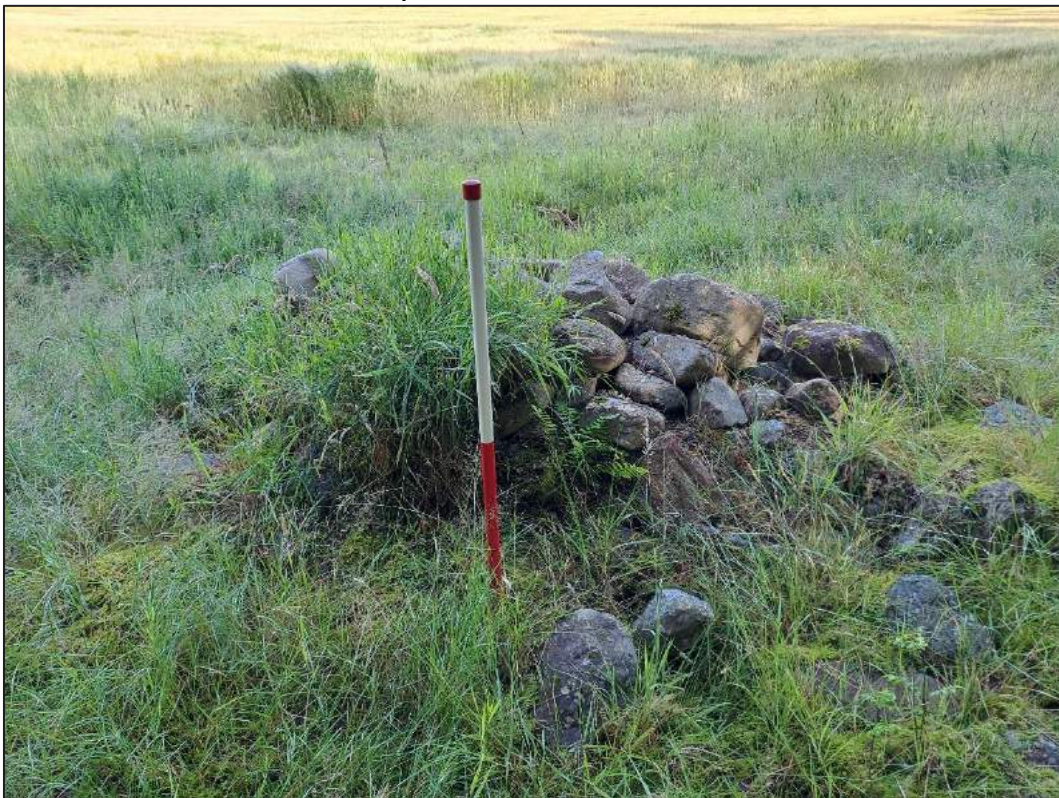
(SLR 6) Photograph 19: (NH 64278 70416) View northeast along the southeast boundary of the Original Land Under Option. A modern clearance cairn with very little overgrowth.
